## Operational Issues with Wind Turbine Blades in a Coastal Environment

Marianne Rodgers, Robbie Sanderson, and Heather Norton

Wind Energy Institute of Canada

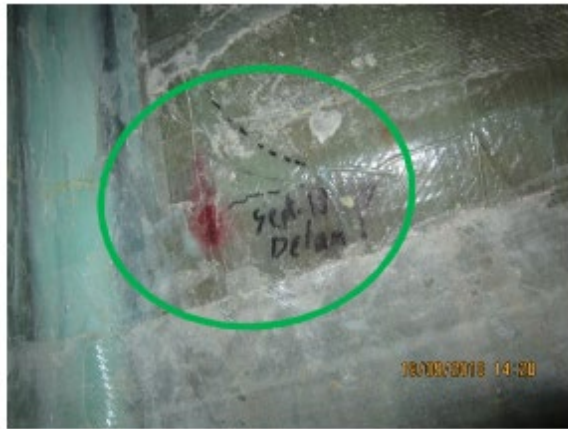
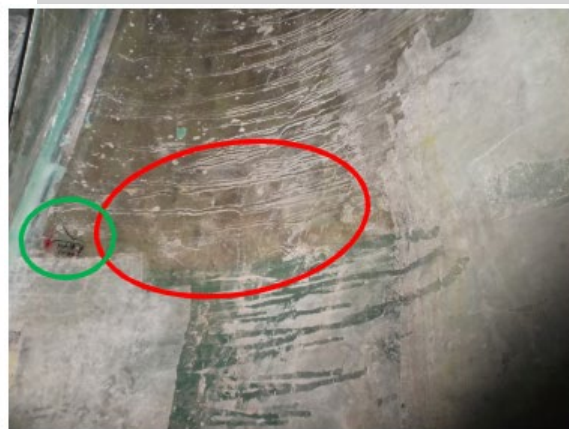
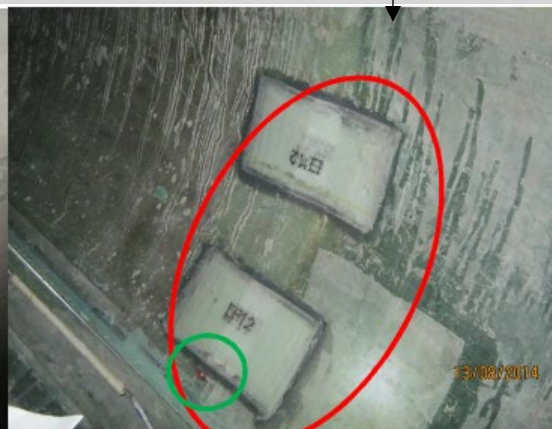
September 2013

October 2013

August 2014

Example of a suction side delamination. The red and green circles mark the same locations on the blades

- April 2013 – Wind farm was commissioned
- Fall 2013 – Blade inspection found cracks in bonding seams, delamination near roots at the suction side. Repairs undertaken.
- Summer 2014 – Further inspections of T1-5 highlighted root core delamination as the biggest issue.
- 2015/16 – Blades were run through a duration and ultimate failure test at a test facility. They identify the same issues with delamination that WEICan experienced.
- 2016 – Consultant hired to develop repair instructions to reinforce the blades. Every blade reinforced under warranty along with a set of spares that WEICan purchased.
- 2016 – WEICan bought 12 more blades. These were not reinforced.

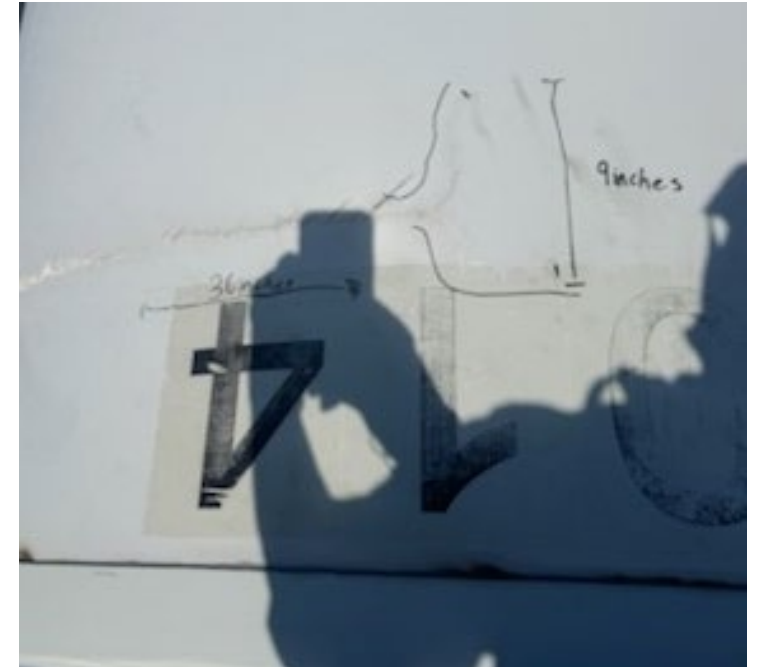
Service Inspection September 2024

- Summer 2020 – Inspection found crack near root at pressure side of 1 blade on T5. Blade was replaced and the rotor was re-balanced.
- Summer 2023 – Began repairs on another set of spare blades.
- October 2024 – Inspection found 4 blades with cracks near the root on the pressure side: 2 were on T4 and 2 on T5. Consultant hired to create reinforcement instructions for the pressure side. They recommended creating 'splints'.
- November 2024 – 3 more blades were given core ramp/shear web retrofits along with “splints”

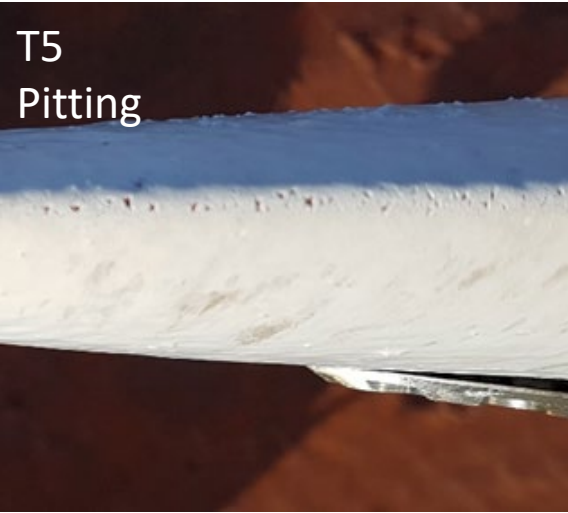
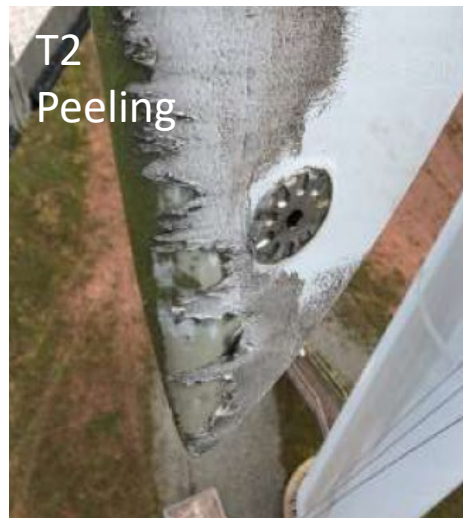
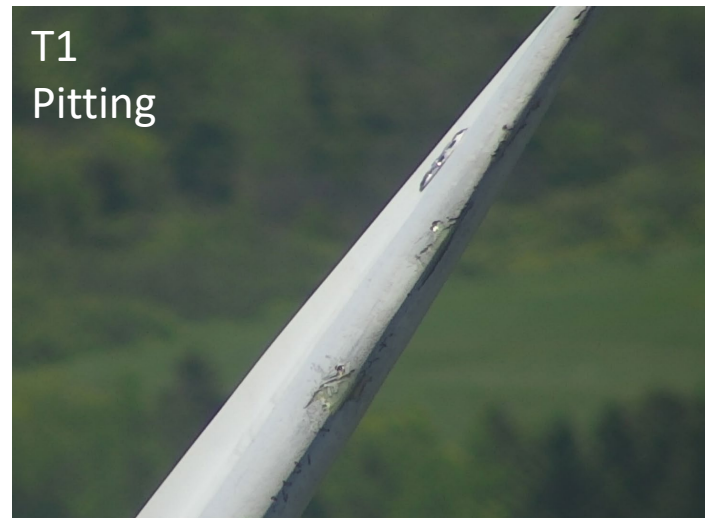
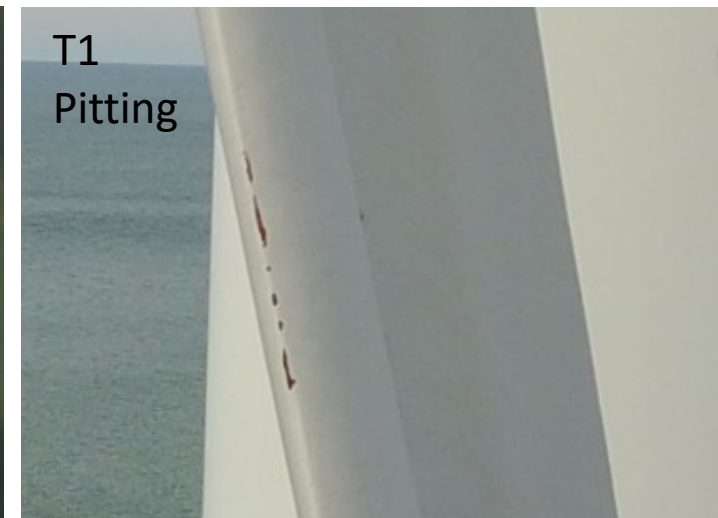
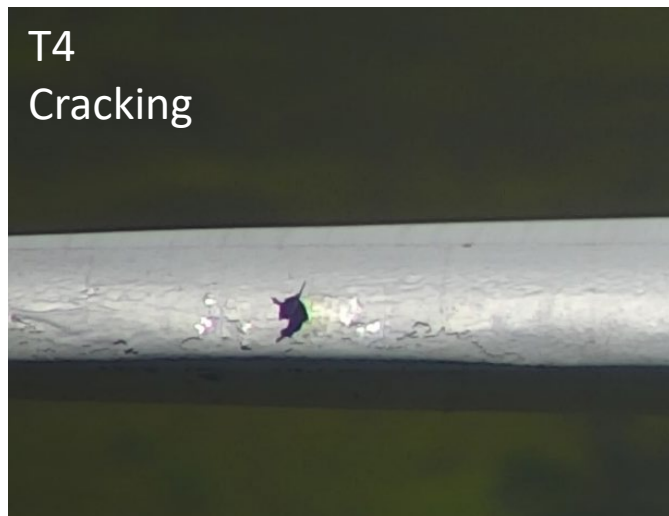
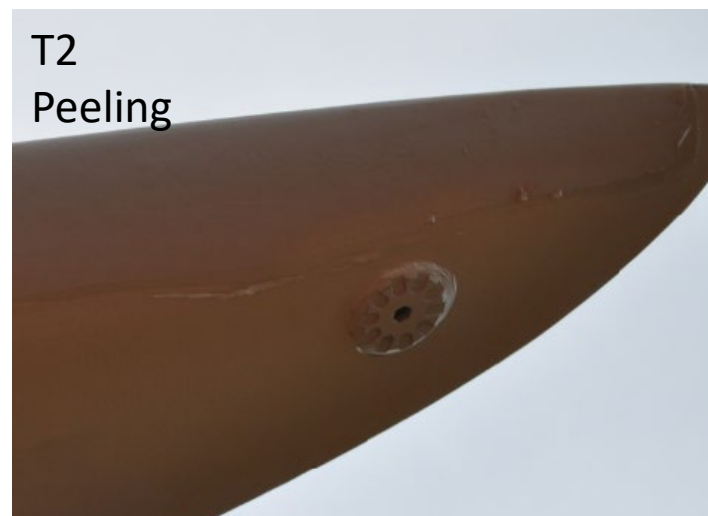
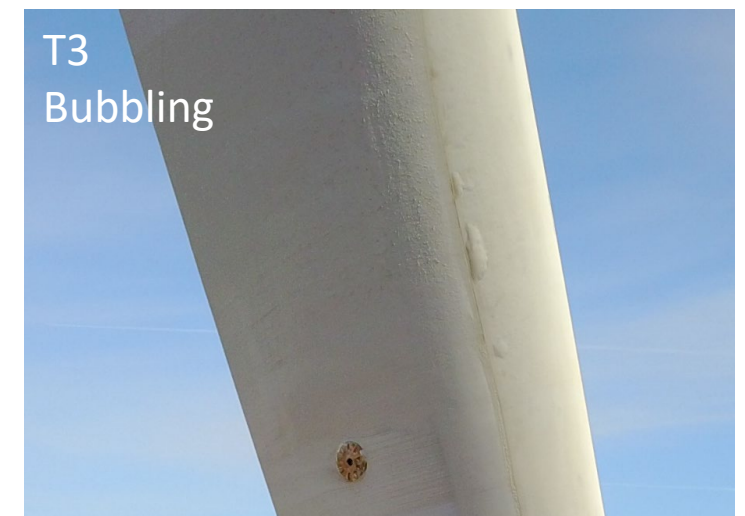
# LEP Failure 2016 and 2019

Leading edge damage was observed on most blades: - Pitting - Cracking - Peeling - Bubbling

- LEP providers attribute premature failures to improper/inadequate surface preparation and installation
- Usual causes:
  - Epoxies/adhesives not appropriately activated
  - Surface was not adequately cleaned
  - Blade repairs with fillers or coatings ahead of installation where still curing
  - Conditions may have been appropriate at the start, but were not sustained
  - Skills/experiences of technicians is not adequate
- Original blade manufacturing/blade quality is very important
  - How was it put together, filler, adhesion methods

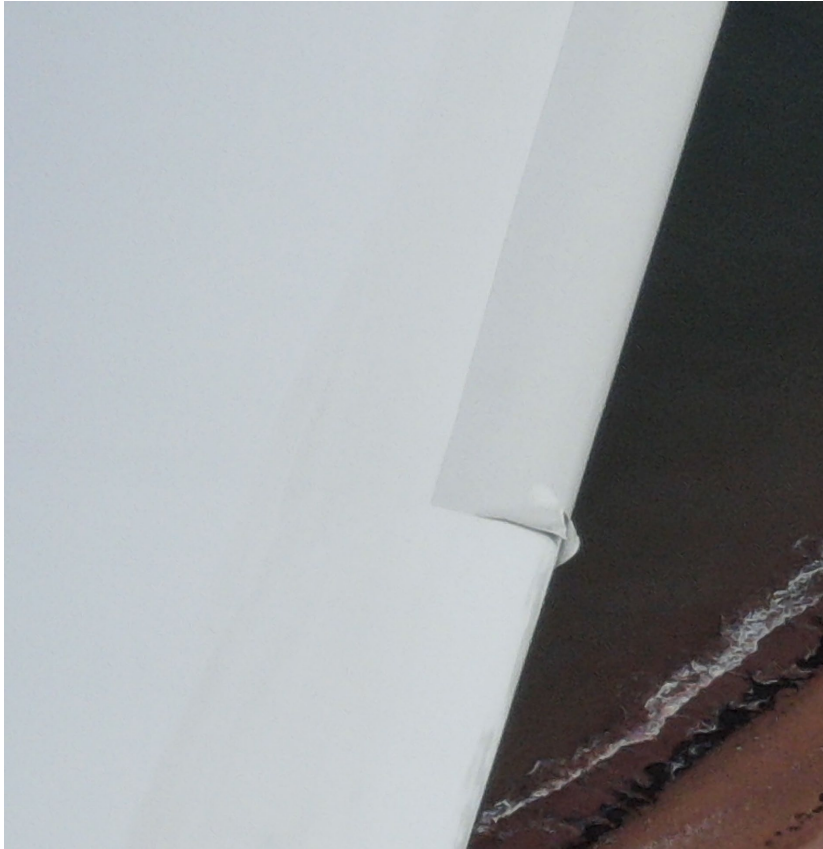
## T4 Tear

| LEP | Type of LEP | Turbine | Date Applied, Damage observed | Types of Damage Observed |
|---|---|---|---|---|
| 6 | Tape (polyurethane) | T4 | 2025 | Tear, peeling |

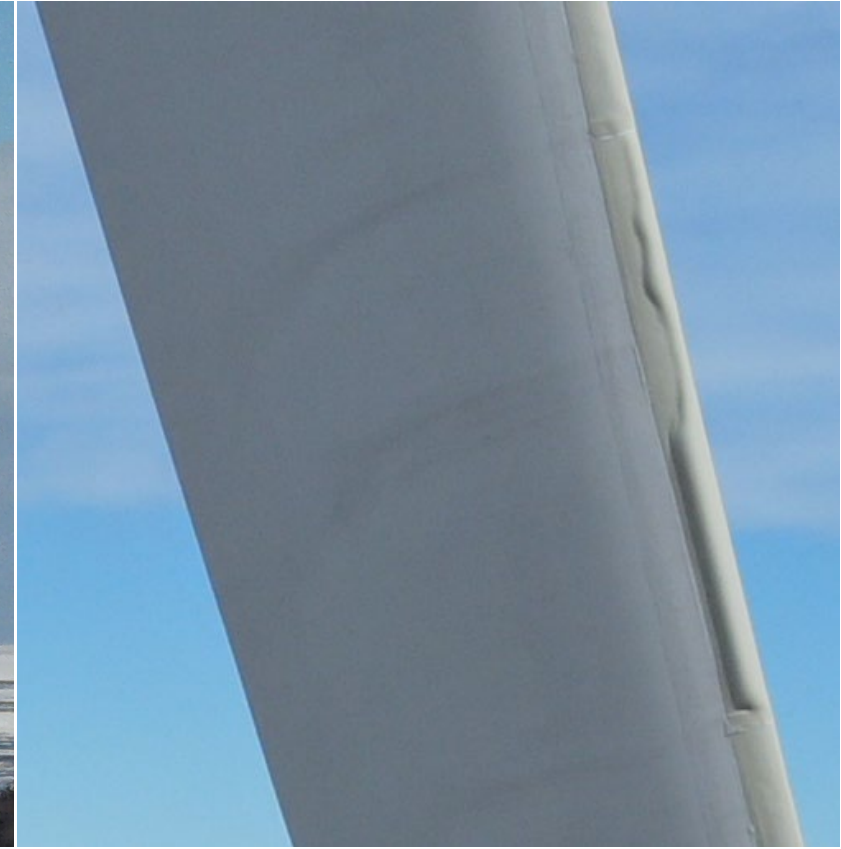
## T5 Air bubbles

- Summer 2019 – Reapplication of most products
- March 2021 – WEICan represents Canada on IEA Wind Task 46 – Erosion of Wind Turbine Blades
- Summer 2021 – Application of 5<sup>th</sup> LEP on T1 & T4 – T4 was rejected by manufacturer
- Summer 2022 – Application of 5<sup>th</sup> LEP on T2, T3 & T5, Reapplication on T4
- January 2023 – Inspections show 5<sup>th</sup> LEP detached from Blade 1 leading edge and started to bubble on Blade 2 of T1
- September 2023 – 5<sup>th</sup> LEP repaired on T1
- Winter 2025 – 5<sup>th</sup> LEP applied to new blades on T5; 6<sup>th</sup> LEP applied to new blades on T4
- Spring 2025 – bubbles on T3 and T5 LEP; tear on T4 LEP
