## Operational Issues with Wind Turbine Blades in a Coastal Environment

Marianne Rodgers, Robbie Sanderson, and Heather Norton

Wind Energy Institute of Canada

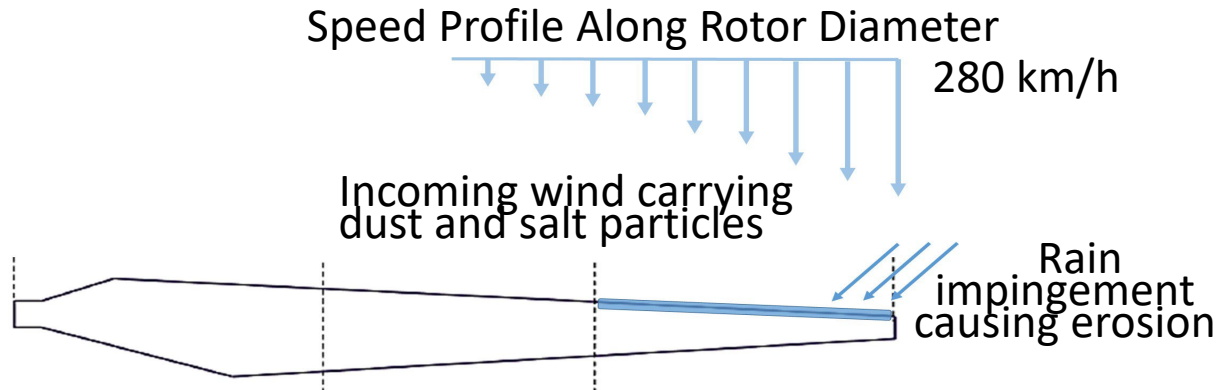
- Wind turbine blades are exposed to precipitation and airborne particles that can erode their surface coating
- Due to the blades' high tip speeds, the portion of the blade furthest from the base usually receives 70% to 80% of the erosion damage
- Untreated, leading edge erosion can reduce energy production, increase maintenance costs and downtime, and, eventually, affect the blades' structural integrity
- Many types of leading edge protection (LEP) materials have been designed to help prevent the erosion of the blade edge
